Completion Report of Storm Water Project C-1

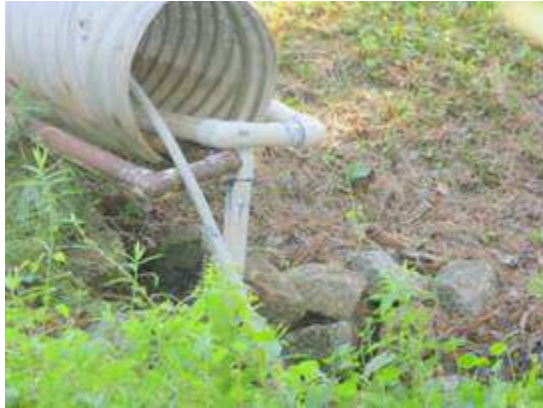
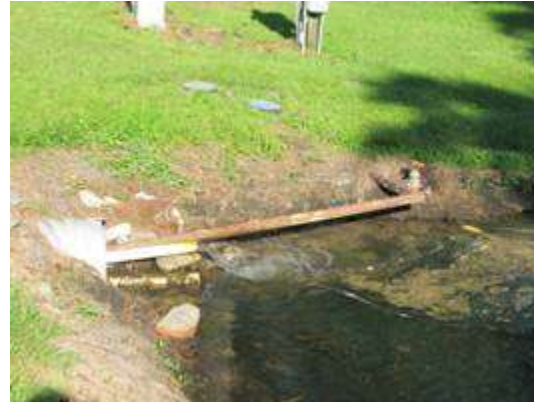
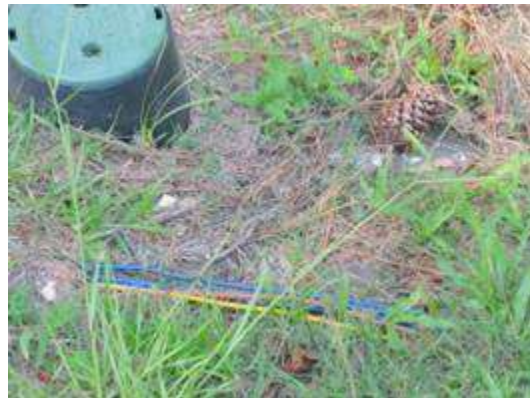
Pond 23 and the outfall line under Clubhouse Drive cannot handle anticipated storm volume. This and the completion of Project C-2 will result in overtopping of the roadway and flooding adjacent yards.

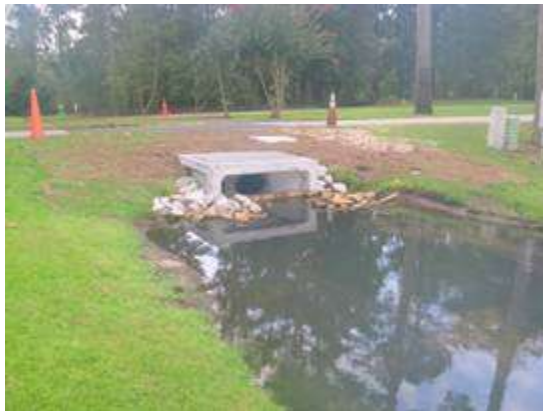
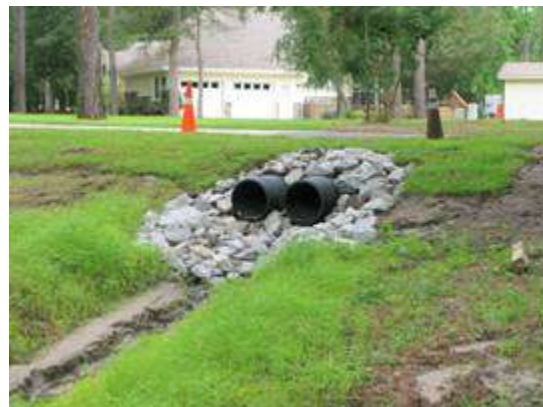
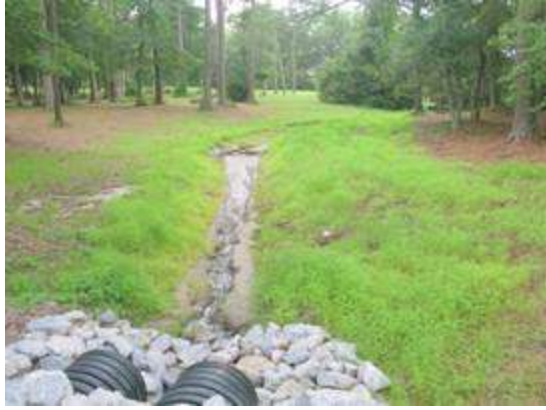
This project was started in late July and finished in mid August. The estimate for the work was \$25,000(including contingency). The bid came in at \$19,500 and the final cost was \$17,800. (see the file for all the details) The contractor performed extremely well on this project.
